July 5, 2019

Carolina Bay, LLC.

Re: Carolina Bay Canal
North Myrtle Beach, SC

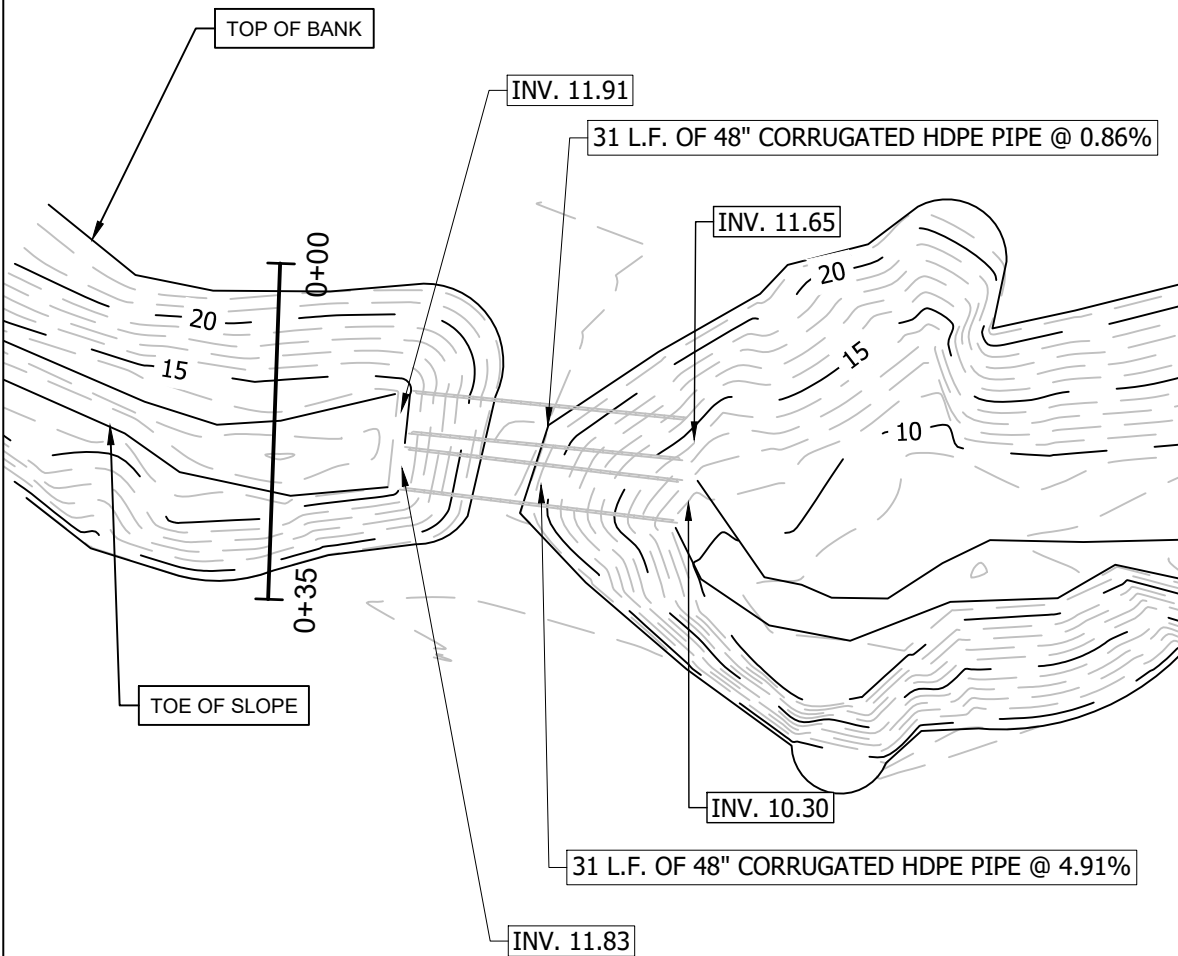
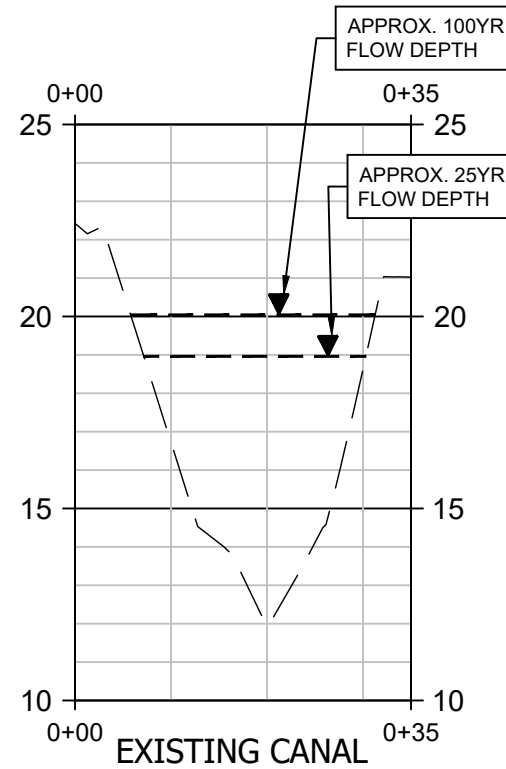
EXISTING CANAL CROSS SECTION

We modeled the various drainage contributory areas in order to create a drainage model of the canal prior to the instillation of the current crossing. Hydrographic information was estimated using publicly available land cover information, soil type data, and drainage paths. The existing canal appears to have a cross sectional area of approximately 165sf with a top of bank width of approximately 30ft as shown in Appendix A. Approximately 125 linear feet of the canal was surveyed roughly centered around the existing crossing, linear slope along this section of canal appears to be approximately 4%. Soils in the area appear to consist of sands and clayey sands which are highly erodible.

During our visit to the site it appears that significant erosion of the channel has occurred in the recent past. It also appears that the existing canal crossing, utilizing 2-48"

Corrugated Plastic Pipes was over topped at some point in the recent past, likely in the Hurricane Florence rain event of September 2018. The combined flow capacity of these two existing pipes is estimated to be approximately 533 cubic feet per second.

At this time we recommend that a new canal crossing be designed as the current solution appears to be inadequate. This new crossing design should take into account the flows generated by the tributary drainage area and the likelihood of large debris within the flow. This new crossing design may take the form of a bridge, box culvert, pre-fab metal culvert, or other large stream crossing system.

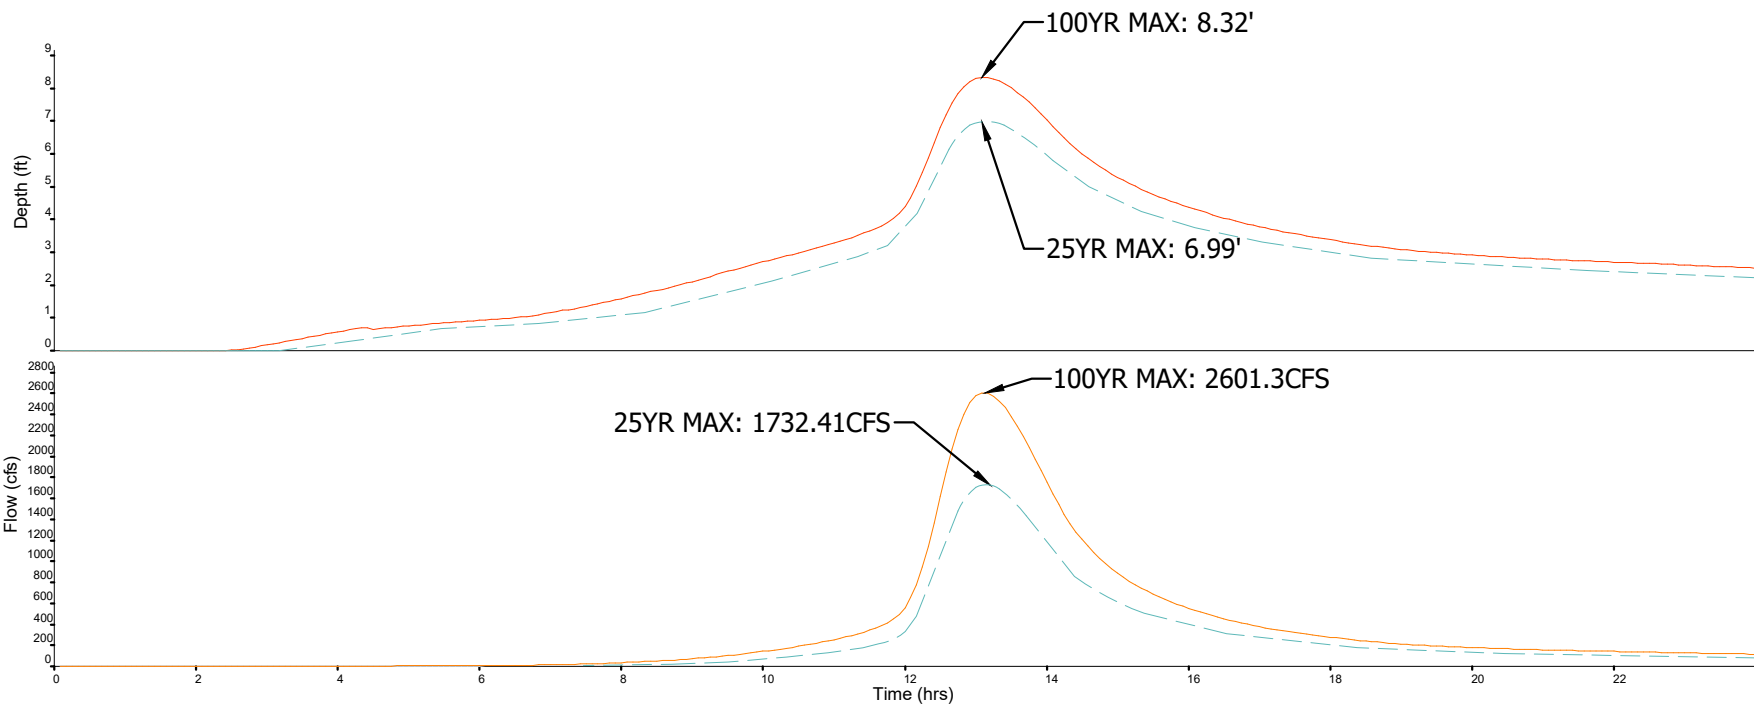
HYDRAULIC MODEL RESULTS

Our calculations focused on the 25 year and 100 year storms as they will be the driving factors in designing a new crossing apparatus. The total canal flow and flow depth are in Table 1 below. More detailed results are attached in Appendix B.

| | Channel Flow (cfs) | Flow Depth (ft) |
| 25 Year | 1732.41 | 6.99 |
| 100 Year | 2601.30 | 8.32 |
